ONE SITE, 57 ISSUES

The Channel 7 current affairs program Today Tonight broadcast in June 2007 video footage supplied by the Construction, Forestry, Mining and Energy Union of alleged safety and health transgressions at the Q-Con construction site on St Georges Terrace in Perth; footage not seen previously – or since – by the authorities. In this exclusive, **Jaci Moore** reports on the review of the video by a panel of safety professionals.

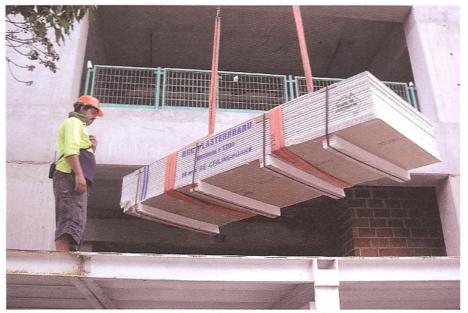
A photo supplied by the CFMEU showing a worker operating at height on a surface without edge protection.
